**COMPOSITE INSULATOR DIAGNOSTICS IN SERVICE AND CONDITION MONITORING IN VERY HARSH COASTAL ENVIRONMENT OF IRAN**

Gholamreza NEMATI  
HEPDC – Iran  
[Nematonline@yahoo.com](mailto:Nematonline@yahoo.com)

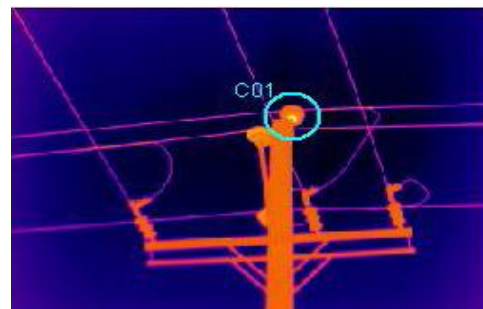
Visual inspection is the most commonly used inspection technique. Binoculars are used to perform remote visual inspections With IR, the temperature distribution along the insulator axis is measured by means of an infrared camera, searching for hot spots associated with possible local defects as shown in figure3

Figure3. An example of IR defect detection of in-service insulators

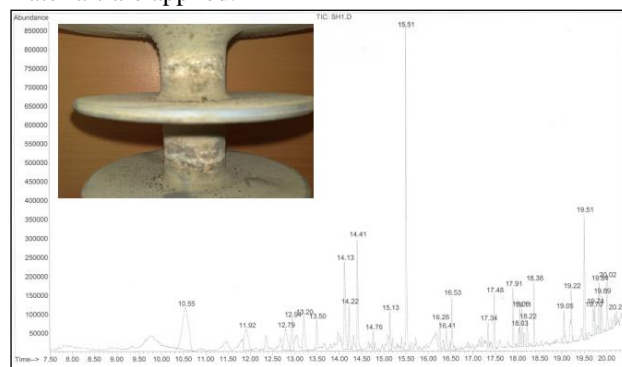
Fig.6: gas chromatograms for composite insulator sample from level 3

Fig. 6 shows a gas chromatograms for composite insulator sample from level 3. The position of each peak in GC spectrum corresponds to an increase in molecular weight of the polymer matrix by one dimethylsiloxane unit, with the molecular weight increasing from the left to the right of the spectrum. The peak height is indicative of the relative abundance of each component. The gas chromatograms have been normalized for sample weight, so that the relative peak areas or peak heights can be consider. As the polymer matrix of silicone materials is primarily formed of polydime-thylsiloxane  $[SiO(CH_3)_2]_n$  the gas chromatograms indicate the distribution of homologous short-chain siloxane in the polymer. Successive peaks for a virgin composite insulator in the spectra correspond to a unit increase in the number of dimethylsiloxane units ( $n = 3; 4; 5; \dots$ ) but In this figure.6, the decrease of the peak height corresponding to

mid-weight siloxanes ( $n = 14$  to  $16$ ) .it comes from very heavy duty condition.

Thus a reduction in the mid-weight siloxanes and generation of low molecular weight siloxanes appears to be characteristic of surface aging of this sample . The low molecular weight species are likely produced through polymerization of the polydimethylsiloxane matrix during the aging process.some reports says that insulators from this group had fault after two up to three year in service

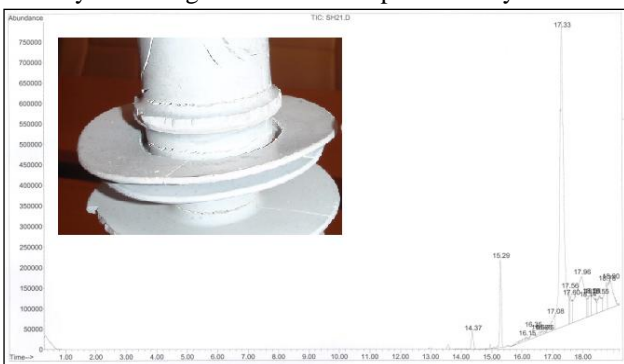
Fig. 7 shows an exposed a silicone rubber insulator in a gas chromatogram analysis given from level 4 sample. Most peaks of this sample correspond to the mid-weight siloxanes ( $n = 16$  to  $18$ ). its can be seen that for this type of xposed sample, the total amount of the detected ions was very small and many peaks were matched to hydrocarbon chemical species,  $C_nH_{2n+1}$ , which be derived from high polymeric diagnostic. The historical data shows that some of insulator belong to this level of diagnostics have been destroyed during of 9 month up to one year after

detection.

Fig.7: gas chromatograms for composite insulator sample from level 4

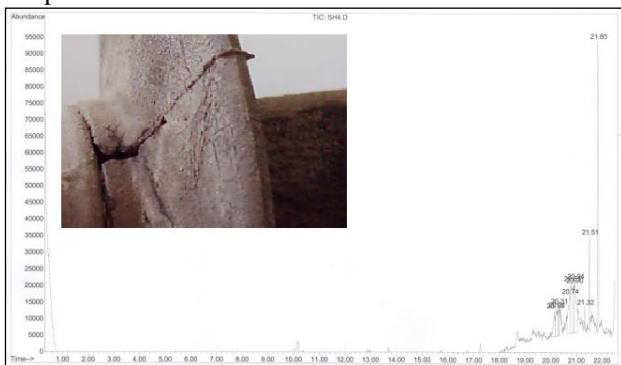
Fig. 8 shows a gas chromatograms for the aged composite insulator in level 5 where the decrease of the peak height corresponding to mid-weight siloxanes ( $n = 20$  to  $22$ ) and the low molecular weight siloxanes increased as a result of final aging. Thus a reduction in the mid weight siloxanes and generation of low molecular weight siloxanes appears to characteristic of surface aging of samples.

Fig8: gas chromatograms for composite insulator sample from level 5
