COMPOSITE INSULATOR DIAGNOSTICS IN SERVICE AND CONDITION MONITORING IN VERY HARSH COASTAL ENVIRONMENT OF IRAN

GESHM ISLAND PILOT PROJECT

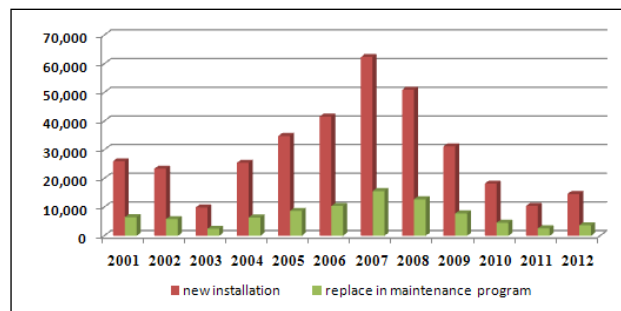
Figure.2: Number of installed composite insulators in the region investigated

level of this region, for which the survey was conducted for, is classified as very heavy category In recent decades, the replacement of porcelain insulators by composite insulators has been considered as an effective approach to overcome undesirable effects of high level marine–desert pollution in the southern coastal regions of Iran. Due to the superior hydrophobicity and the resulting high withstand voltages under pollution, the use of silicone rubber insulators was chosen. Fig. 2 shows the trend of distribution composite insulator installation in region in 2001-2012.

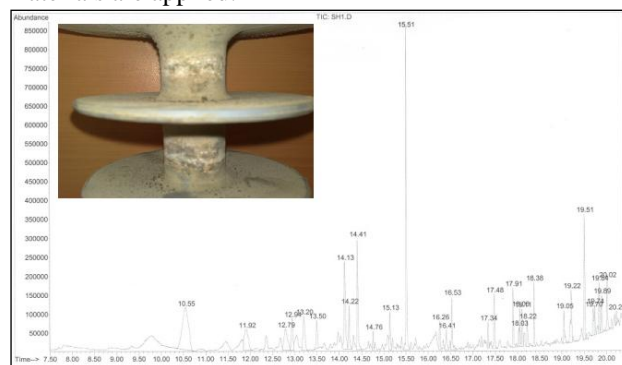
Fig.6: gas chromatograms for composite insulator sample from level 3

Fig. 6 shows a gas chromatograms for composite insulator sample from level 3. The position of each peak in GC spectrum corresponds to an increase in molecular weight of the polymer matrix by one dimethylsiloxane unit, with the molecular weight increasing from the left to the right of the spectrum. The peak height is indicative of the relative abundance of each component. The gas chromatograms have been normalized for sample weight, so that the relative peak areas or peak heights can be consider. As the polymer matrix of silicone materials is primarily formed of polydime-thylsiloxane [SiO(CH₃)₂]_n the gas chromatograms indicate the distribution of homologous short-chain siloxane in the polymer. Successive peaks for a virgin composite insulator in the spectra correspond to a unit increase in the number of dimethylsiloxane units (n = 3; 4; 5;) but In this figure.6, the decrease of the peak height corresponding to

mid-weight siloxanes ($n = 14$ to 16) .it comes from very heavy duty condition.

Thus a reduction in the mid-weight siloxanes and generation of low molecular weight siloxanes appears to be characteristic of surface aging of this sample . The low molecular weight species are likely produced through polymerization of the polydimethylsiloxane matrix during the aging process.some reports says that insulators from this group had fault after two up to three year in service
