**COMPOSITE INSULATOR DIAGNOSTICS IN SERVICE AND CONDITION MONITORING IN VERY HARSH COASTAL ENVIRONMENT OF IRAN**

Gholamreza NEMATI  
HEPDC – Iran  
[Nematonline@yahoo.com](mailto:Nematonline@yahoo.com)

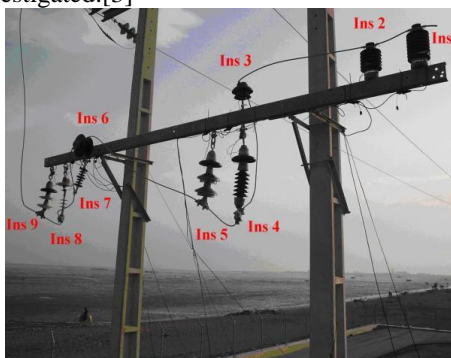
Figure 4. Online leakage current monitoring

In field inspection step long time leakage current

parameters monitoring of sample (5 years) has been selected as a one of main strategy. The assessed composite insulator installed at natural pollution test station beside of other type of porcelain and composite insulators. All different leakage current parameters are also investigated.[3]

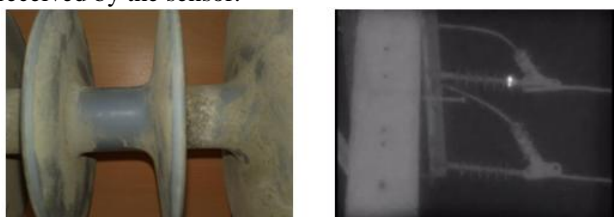
Figure 5. example of "blob" counting by corona camera

For daylight corona cameras, the diagnostic indicator considered is the emission generated by the defects in the UV-C range (i.e. with wavelength in the range 240-280 nm), a bandwidth in which the solar light is filtered by the atmosphere. Corona emission intensity is calculated using the number of pulses of light emission. A counter gives a number proportional to the quantity of "blobs" received by the sensor.
